# **Port Colborne Drain Stormwater Baseline Report**

**October 10, 2018**

Project No: EWB-189999

**EWA Engineering Inc.**

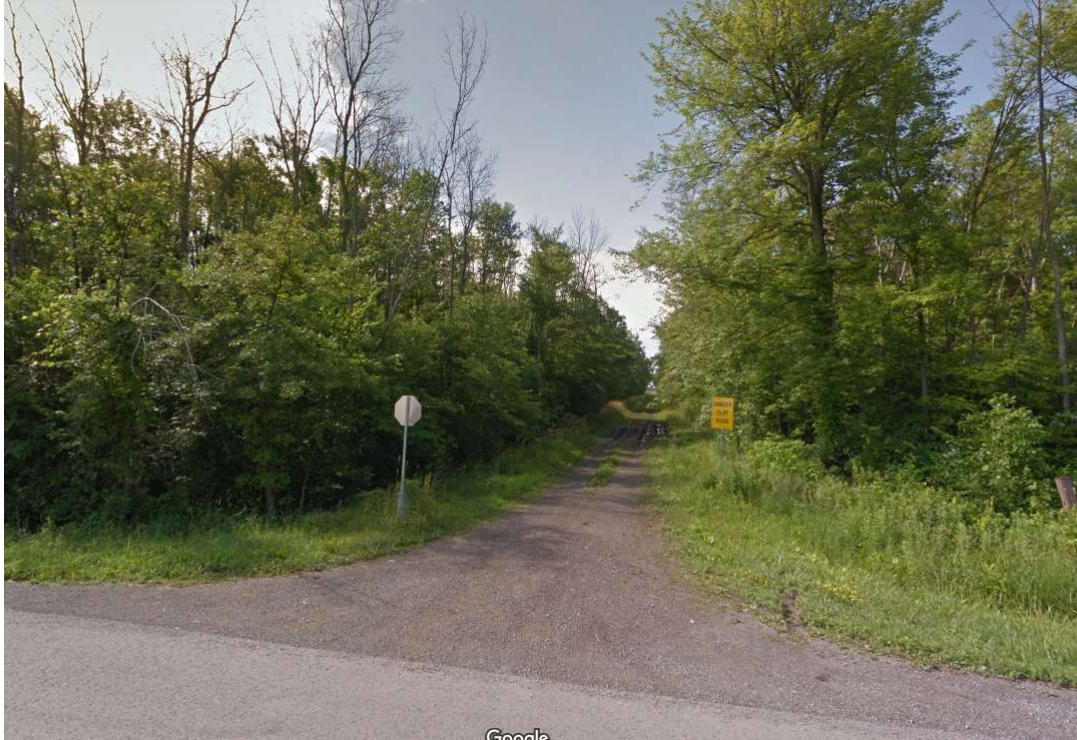
**Figure 9 Wignell Drain Upper end @ Carl Road (clay) and Second Concession Rd.**

The above figure shows that the drain is completely obscured by tree and other growth such that there's little if any discernible evidence that a drain exists. However, complete removal of all vegetation may not be a good objective from an environmental benefit or function. While the drain operates best if there are smooth banks and no obstructions to flow, it will continue to operate even with some obstructions to flow. From a drain recovery aspect, improving the drain function while continuing to meet an environmental benefit, the working portion of the drain, the low flow channel should have all trees removed. Approximately the ½ way point up the bank, all trees should be removed, while the upper portion of the bank can maintain a healthy tree. This is modified with a simple approach, that there exists, such as shown above in figure, a working side to provide drain maintenance. In this case, specific to the Wignell drain, where the drain is running adjacent to the road allowance for Carl Road, trees can be accommodated along the upper bank portion provided access for future maintenance is available from the road allowance. Obviously, this does not apply once the drain leaves the road allowance.

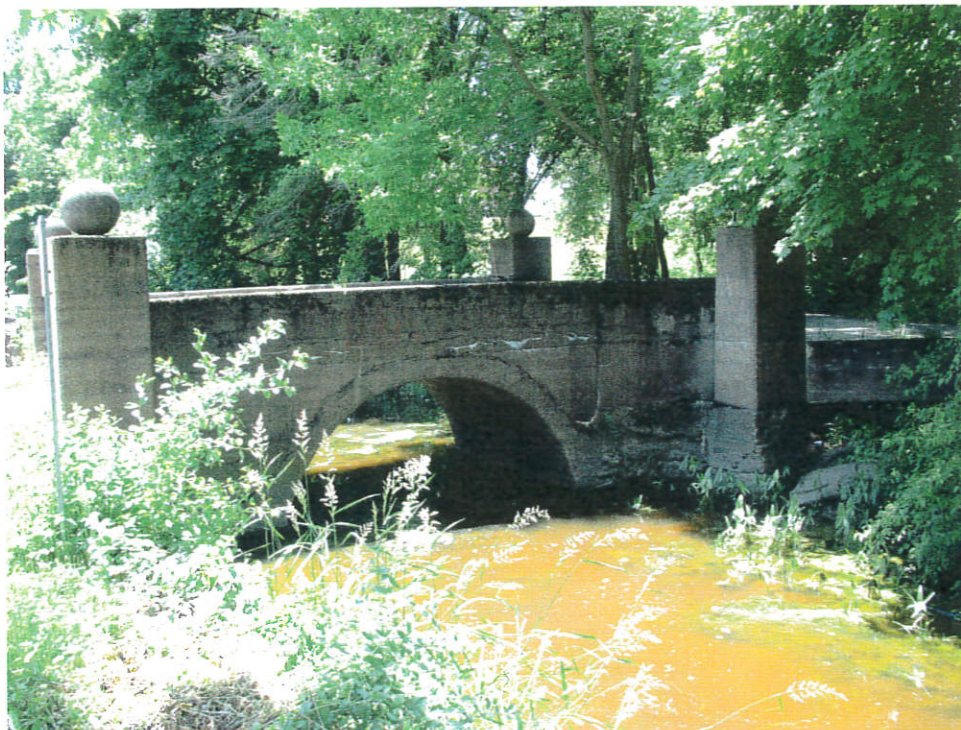
View of the structure, from the north side

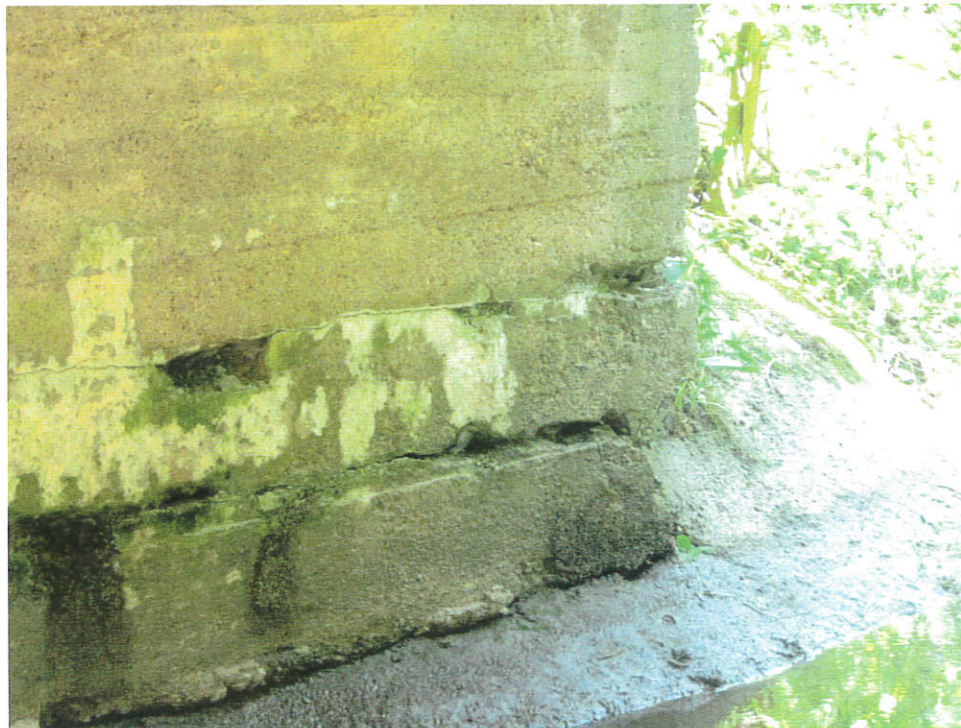
Large cracks on the north end of the west abutment wall

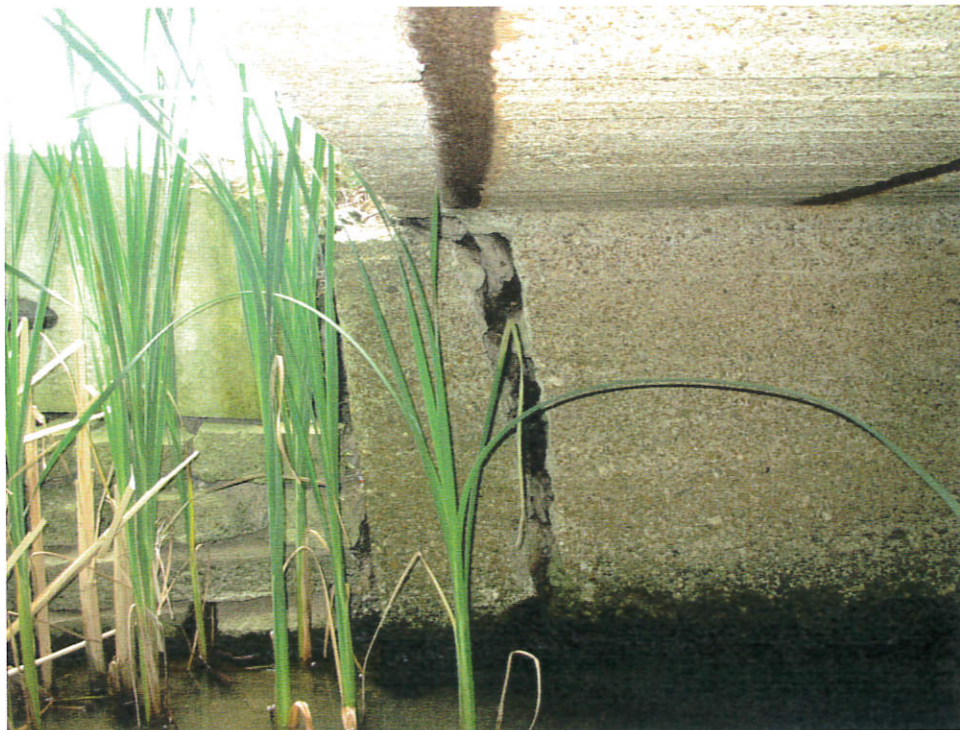
Cracking at the footing at the southeast corner of the structure

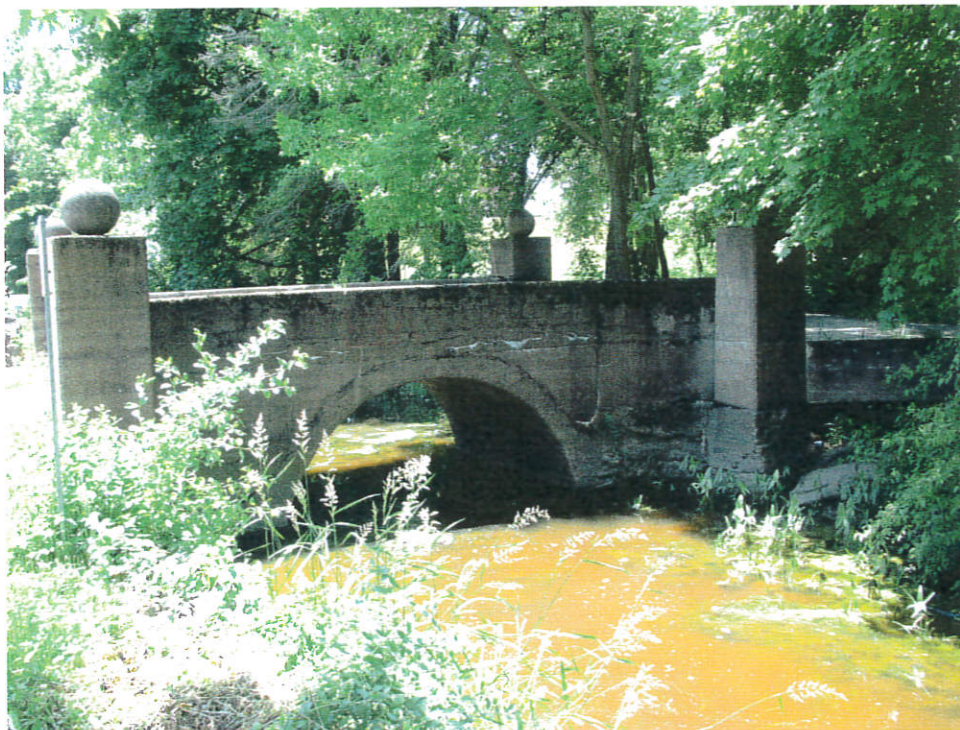
View of the structure, from the north side

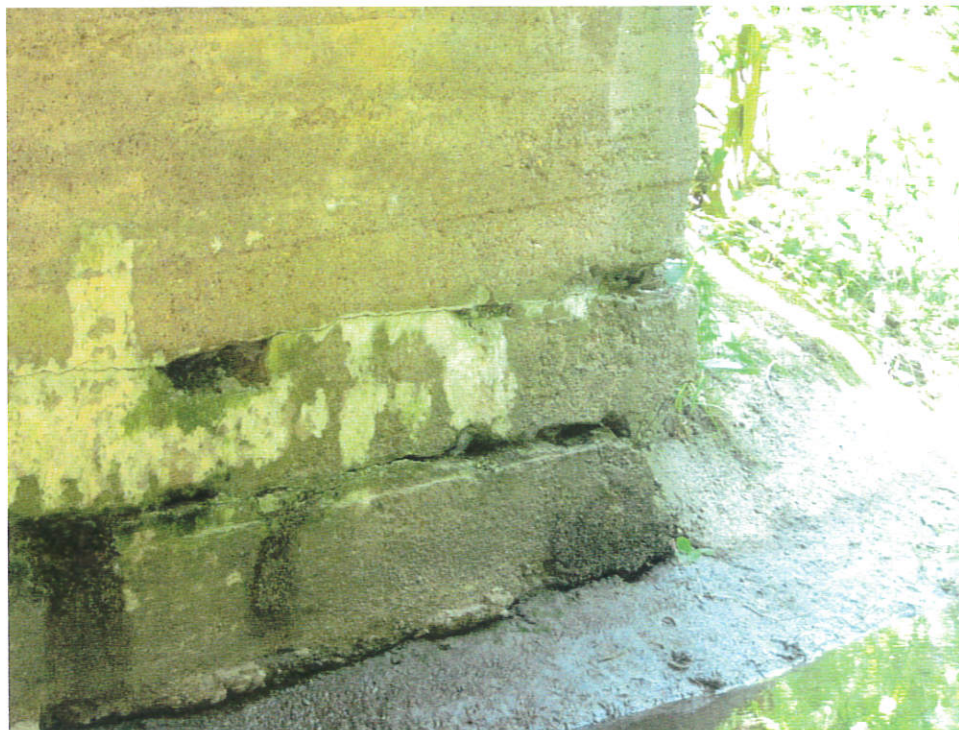
Large cracks on the north end of the west abutment wall

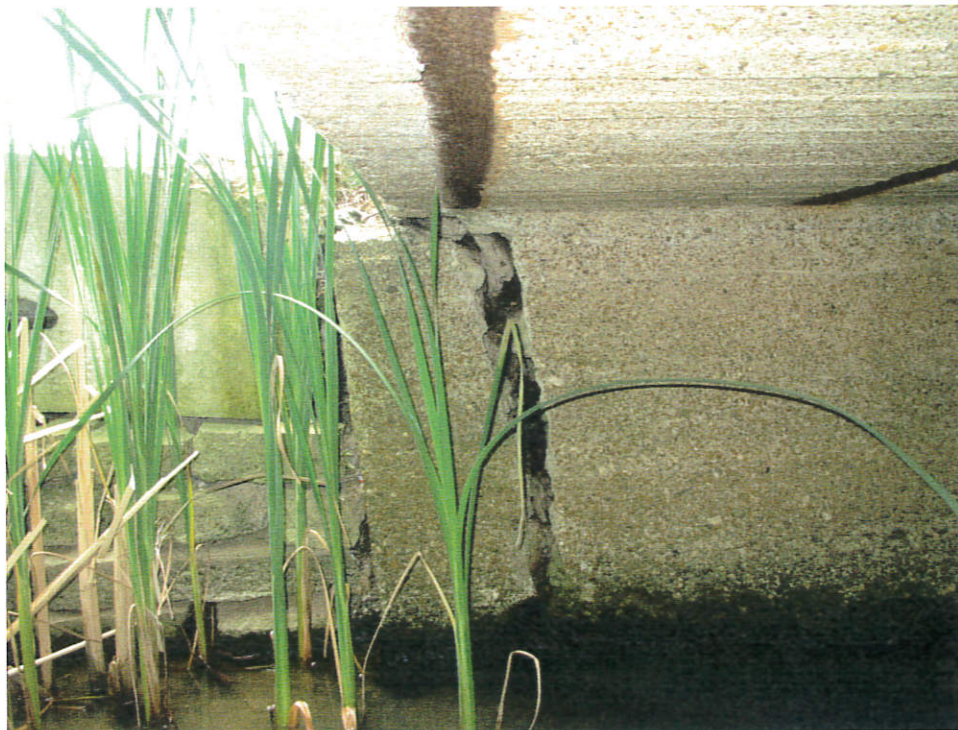
Cracking at the footing at the southeast corner of the structure

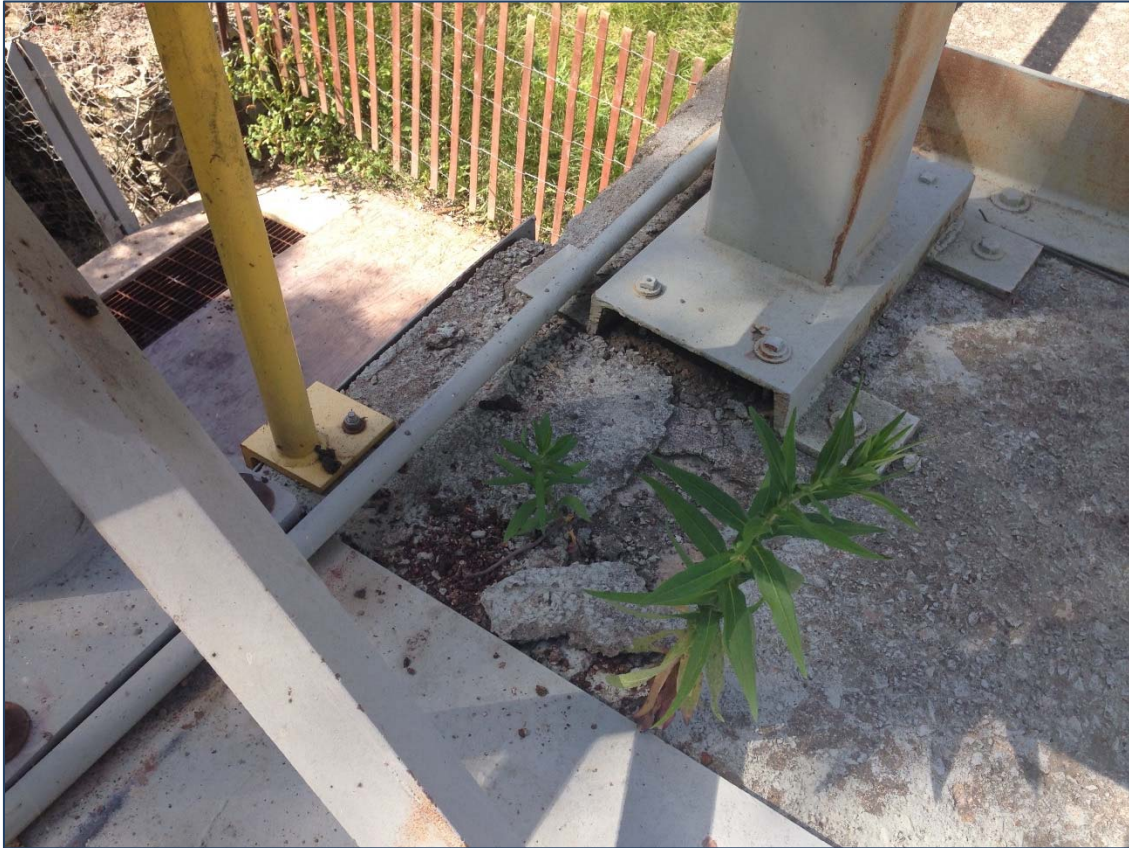
**Figure 3: Localized Concrete Spall**
