# **Port Colborne Drain Stormwater Baseline Report**

**October 10, 2018**

Project No: EWB-189999

**EWA Engineering Inc.**

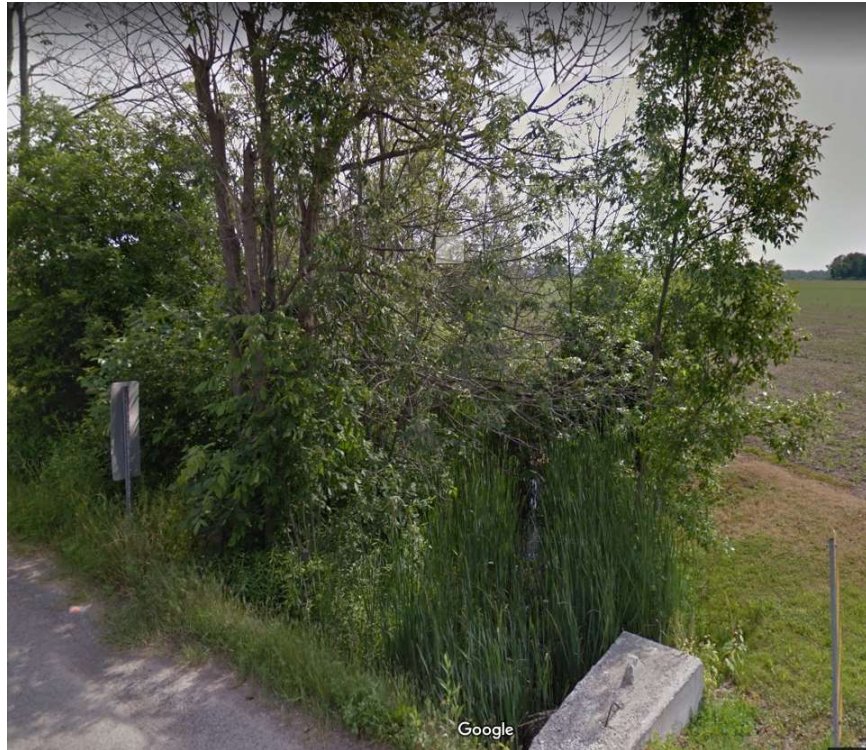
**Figure 7 Obstructed drain; Wignell @ East side of Weaver Road**

This flow is obstructed by tree growth within the banks. Bull rushes provide evidence of standing water. The expected performance of the culvert based on this approach is compromised and unlikely to perform as designed or expected.

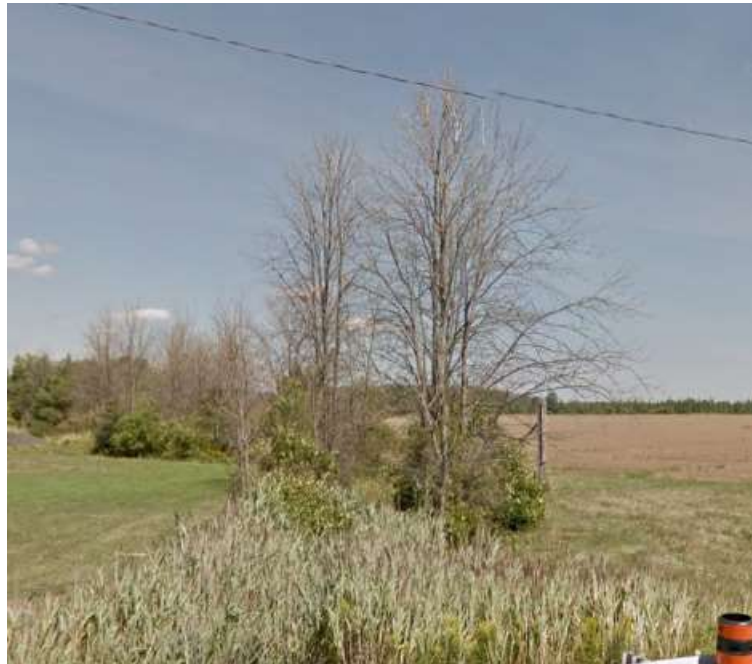
**Figure 8 Dead Ash trees within drain banks**

The presence of ash trees allowed to grow within the drain banks previously, which are now dead or dying from the emerald ash borer will provide a source of wood debris that may potentially block the drain and cause backwater or other degradations in performance.

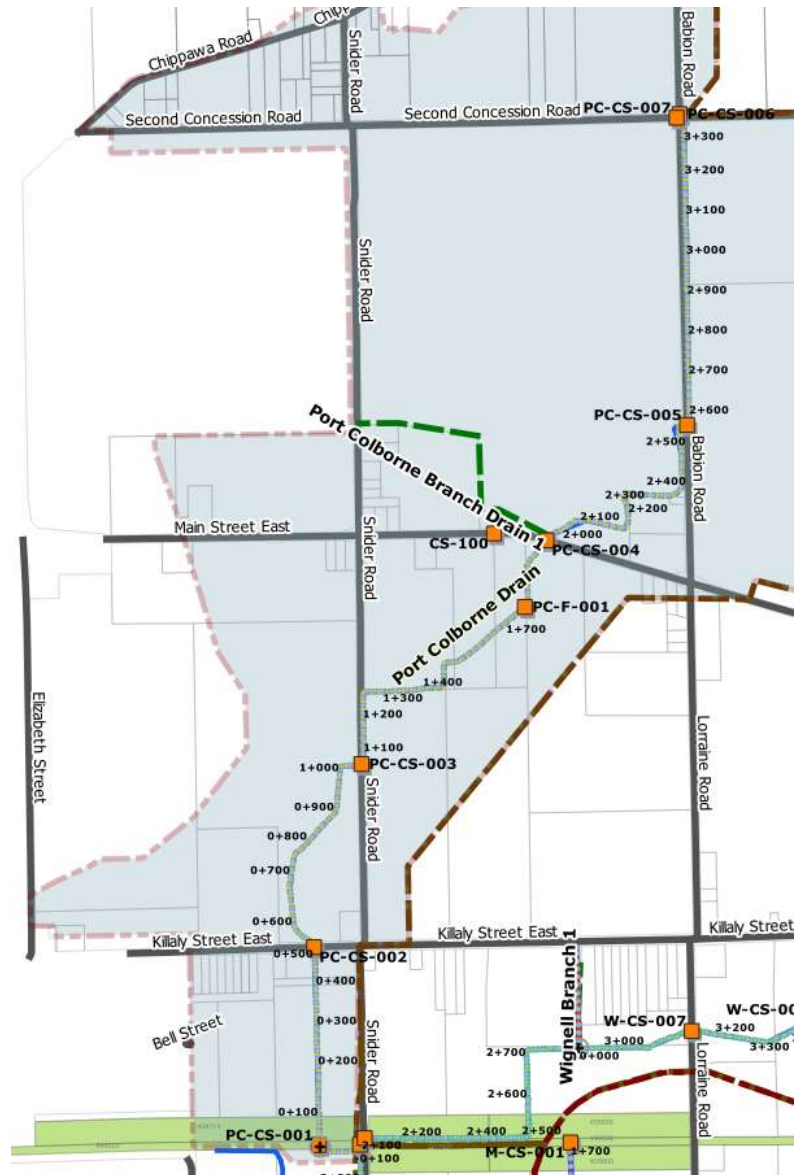
There are 8 structures on the Port Colborne Drain, all are culverts with the exception of 1 fording that is newly constructed in 2016. The re-alignment work lead to a depreciation of the original culvert crossing Main Street East, which is now identified as CS-100 that will be resolved along with the re-alignment of the proposed Port Colborne Branch Drain #1.

Figure 19 Bridge and Culvert Drain Structures

Generally, the culverts are acceptable condition with remaining service life suitable for continued usage. Continued monitoring is recommended including remote inspection (to avoid confined space entry requirements) is recommended. Additional assessment measures may be undertaken prior to finalizing the drain improvement works.

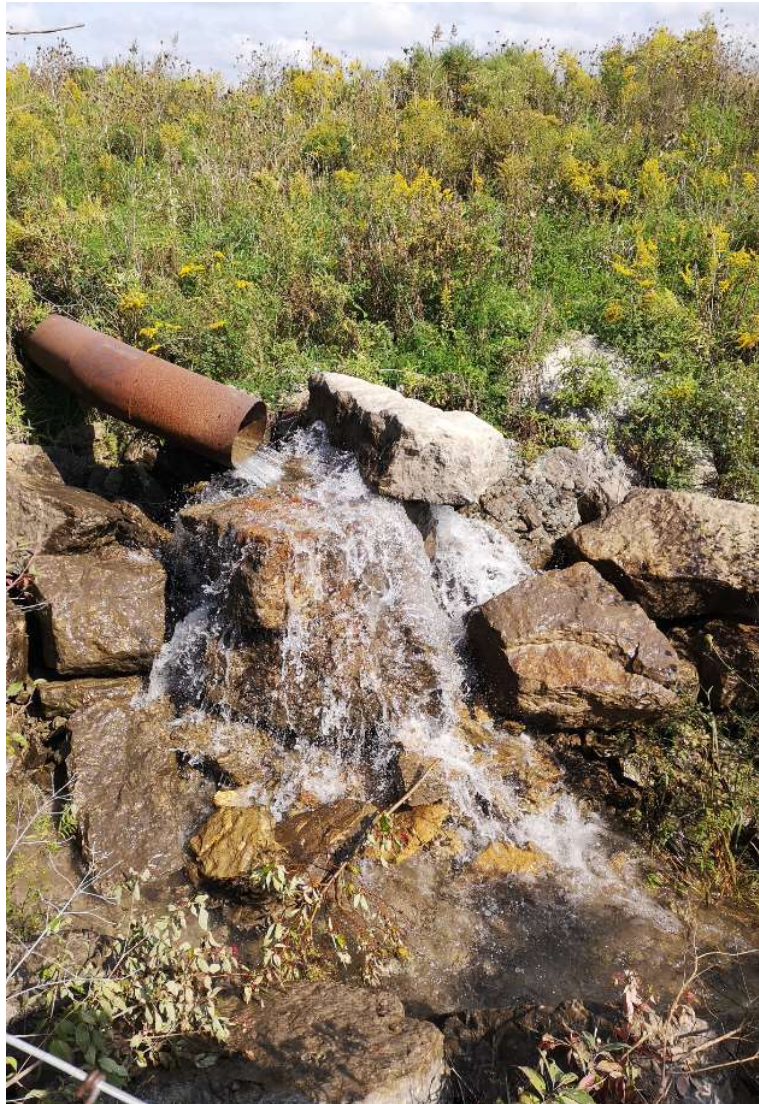
The quarry is pumping water that has passed through the upland clay soils and the clay is known to suspend in the water column for long periods of time, (colloidal property of clay). Discharge of the impounded water in the quarries is monitored and the picture taken on September 19, 2018 shows that the discharge from the quarry is quite clear.

**Figure 20 West Side PC Quarry Pump Discharge - Sept 19**

The picture shows a clear discharge, and it was related anecdotally that runoff into the quarry is influenced by the clay soil and runoff quality from both the drain without a quarry and the runoff from the quarry are similar. The quarry acts as a large detention basin allowing some sediment to settle out of the runoff water but the clay soil contribution is long duration for colour in the water, which is not necessarily an indicator of poor quality.

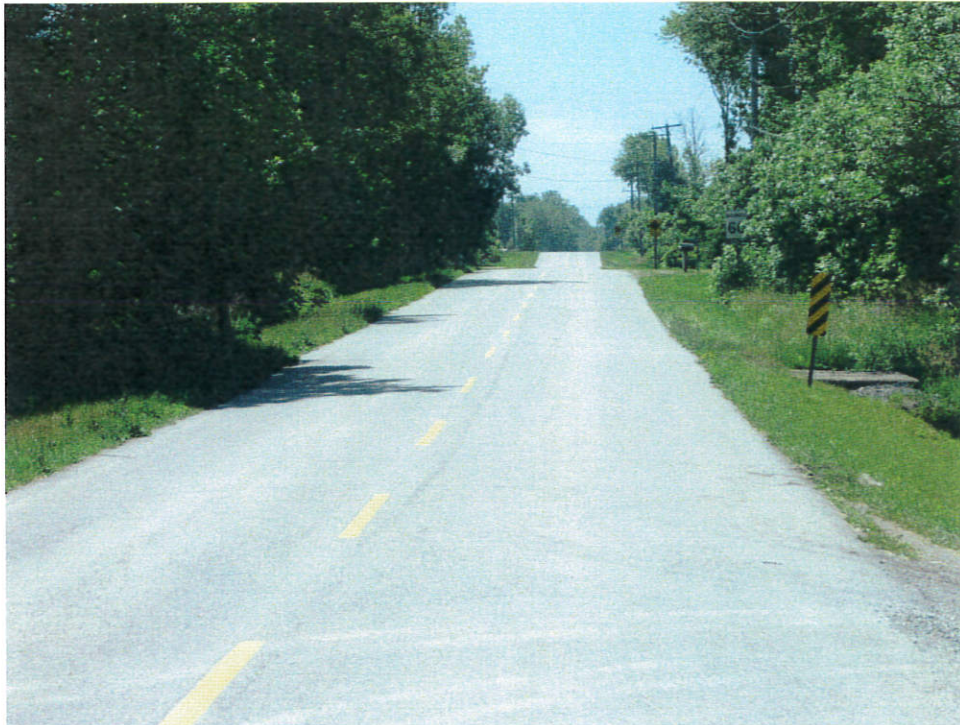
Roadway over the structure - Looking south

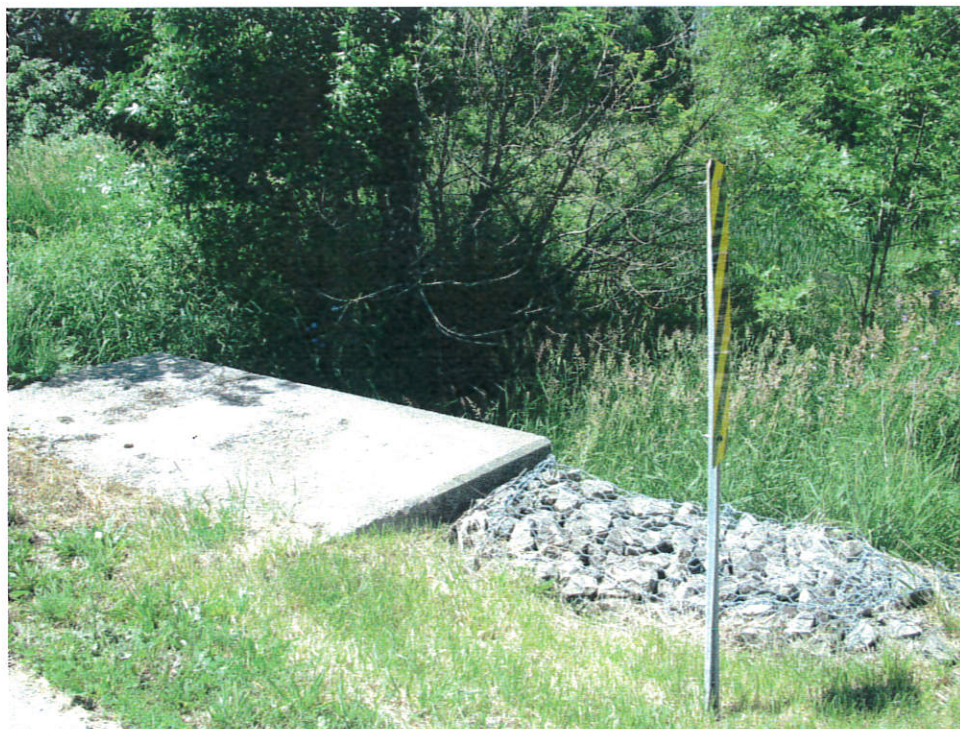
The west end of the structure

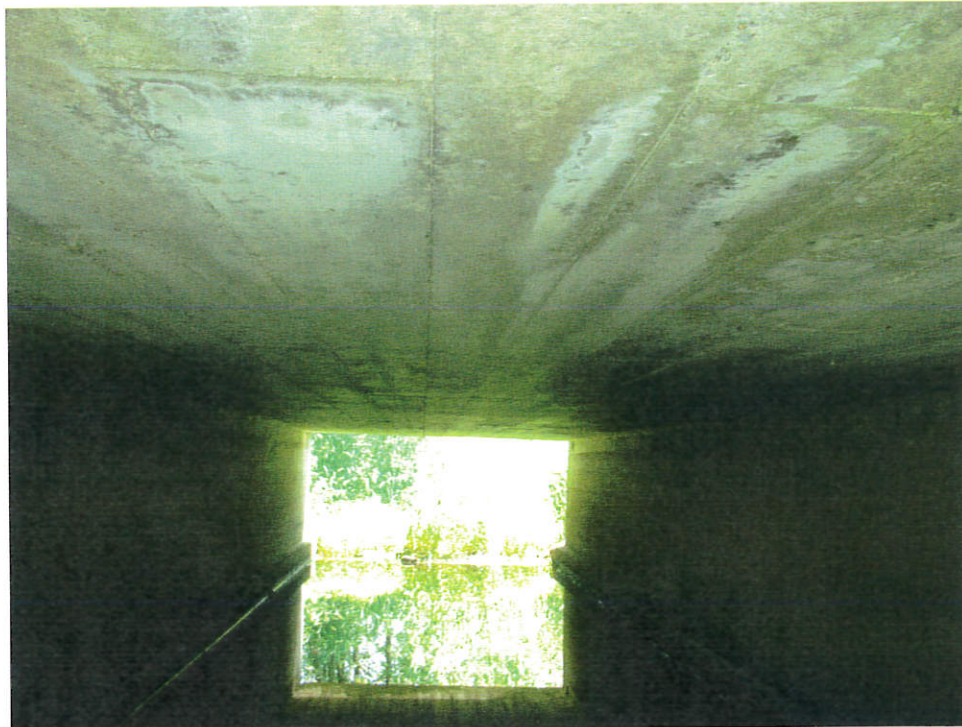
View of the interior of the structure, from the west end

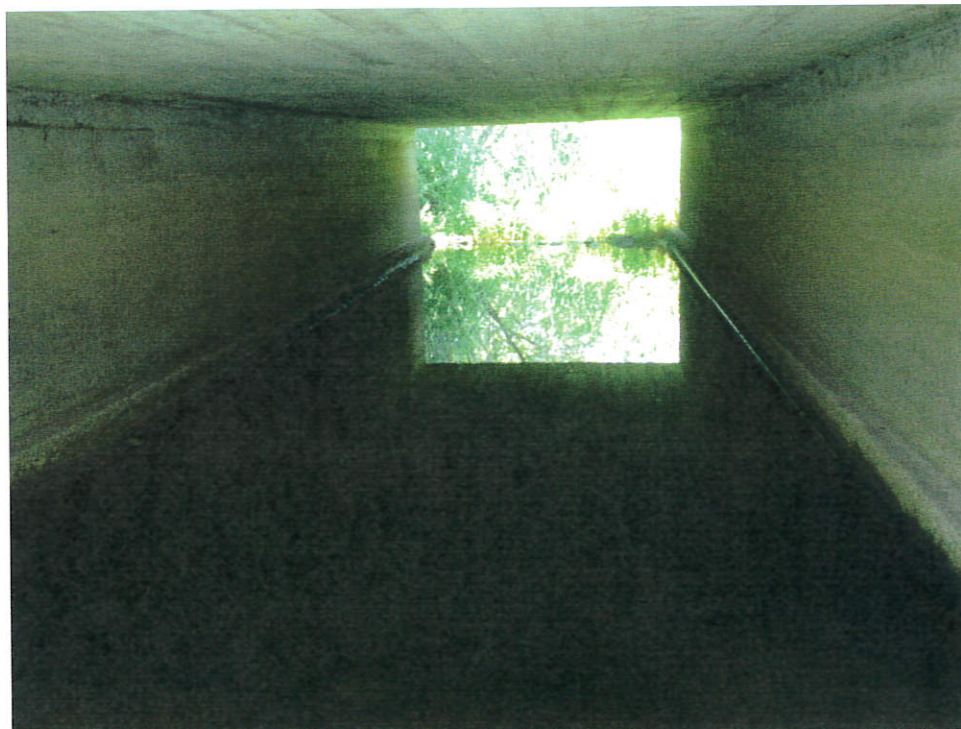
View of the interior of the structure, from the east end

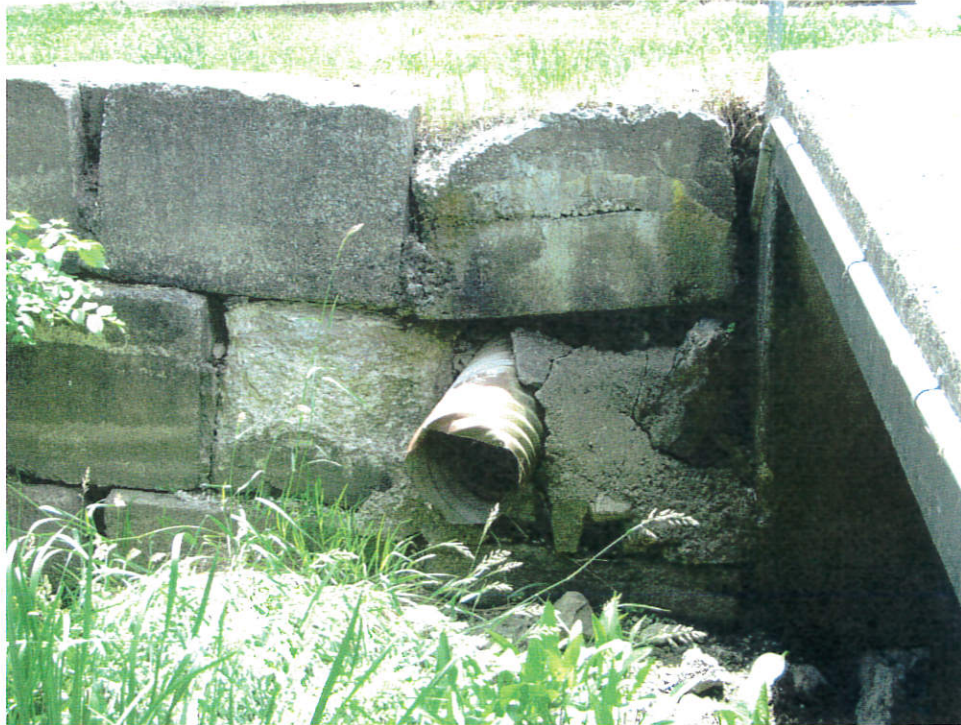
Concrete block retaining wall at the southeast corner of the structure

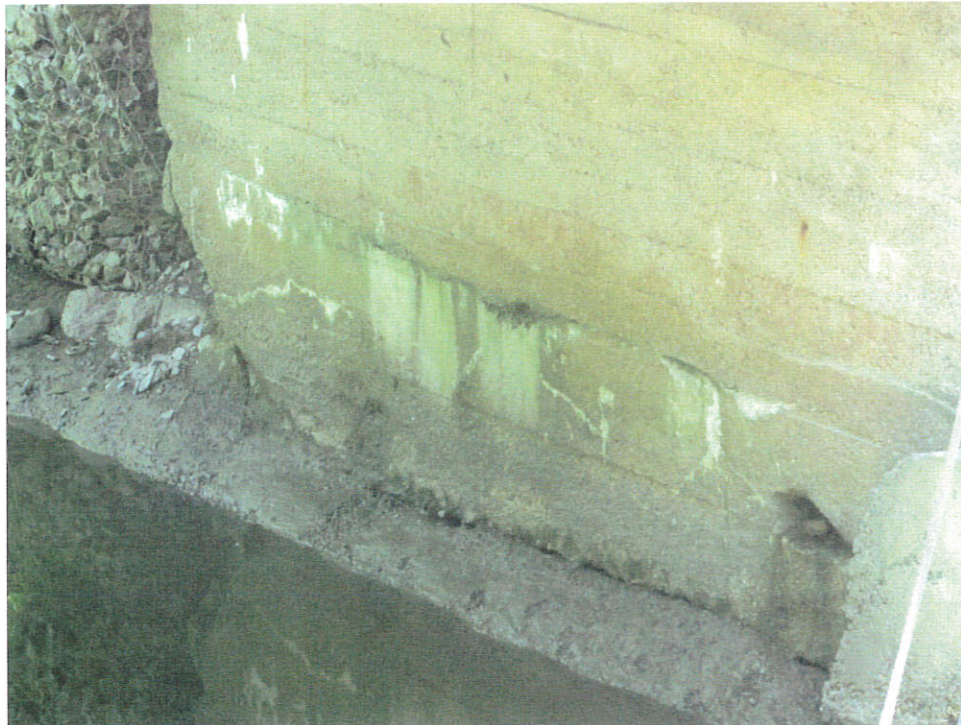
The east wall of the structure

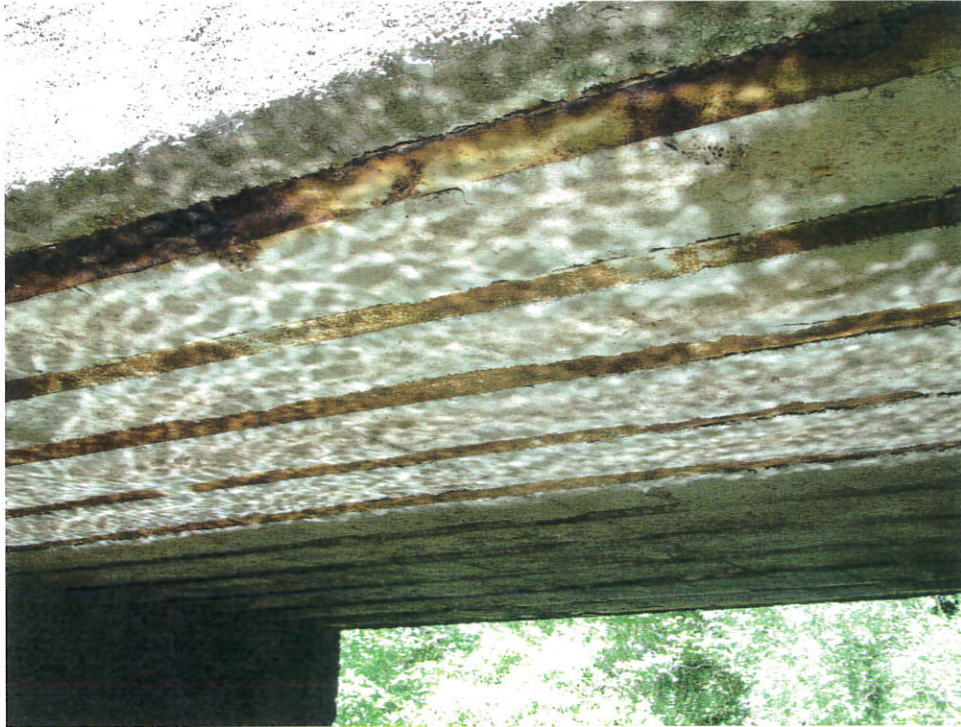
The underside of the structure

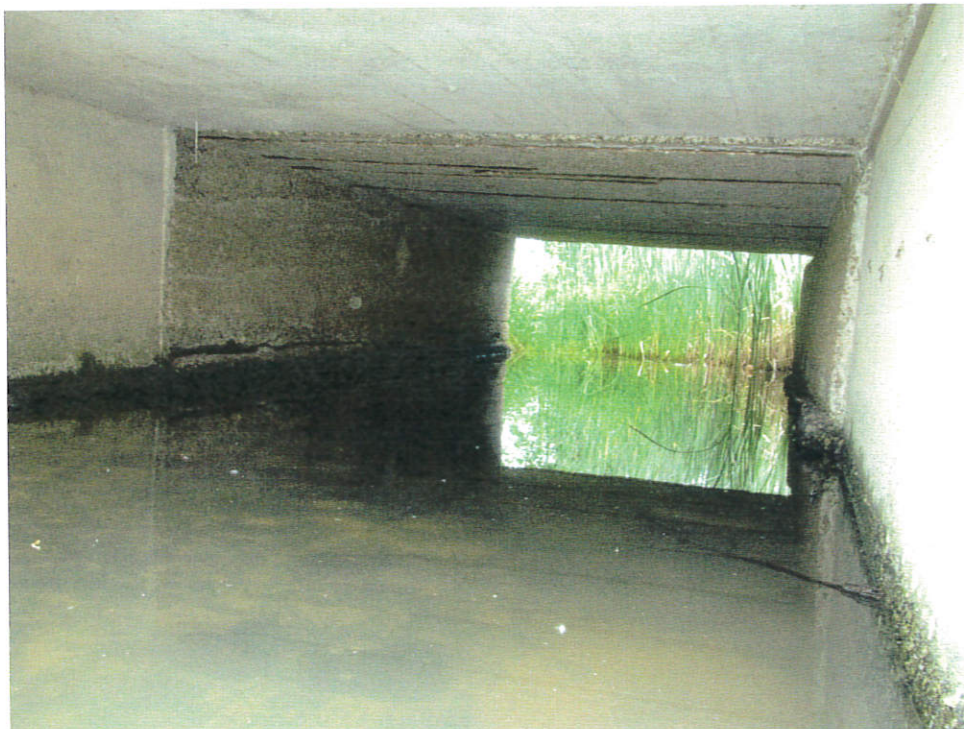
Viewing the interior of the structure from the west end

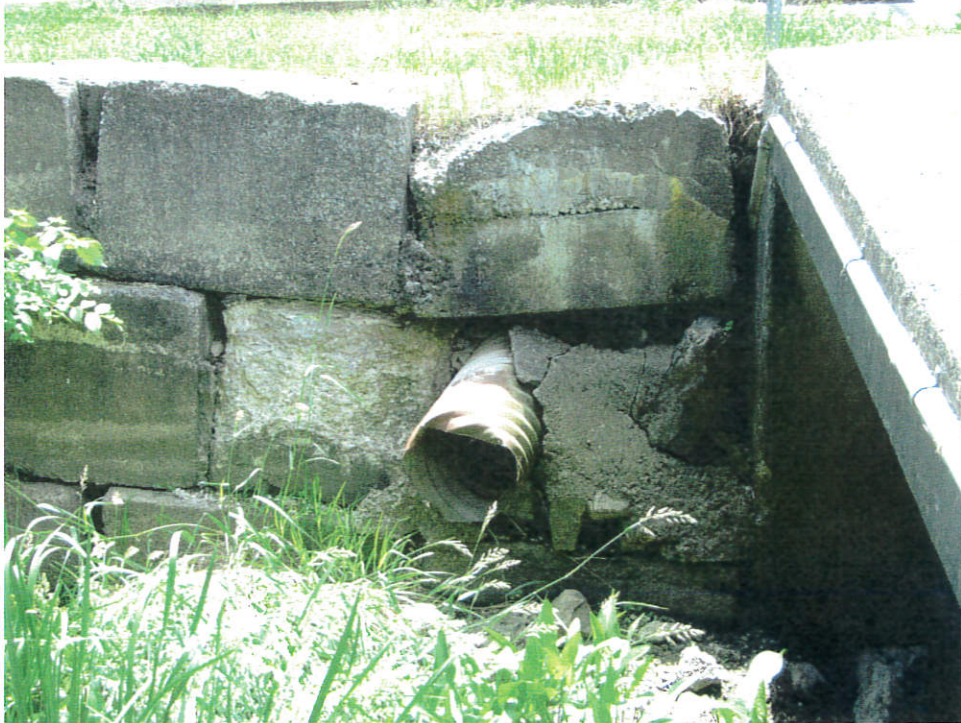
Concrete block retaining wall at the southeast corner of the structure

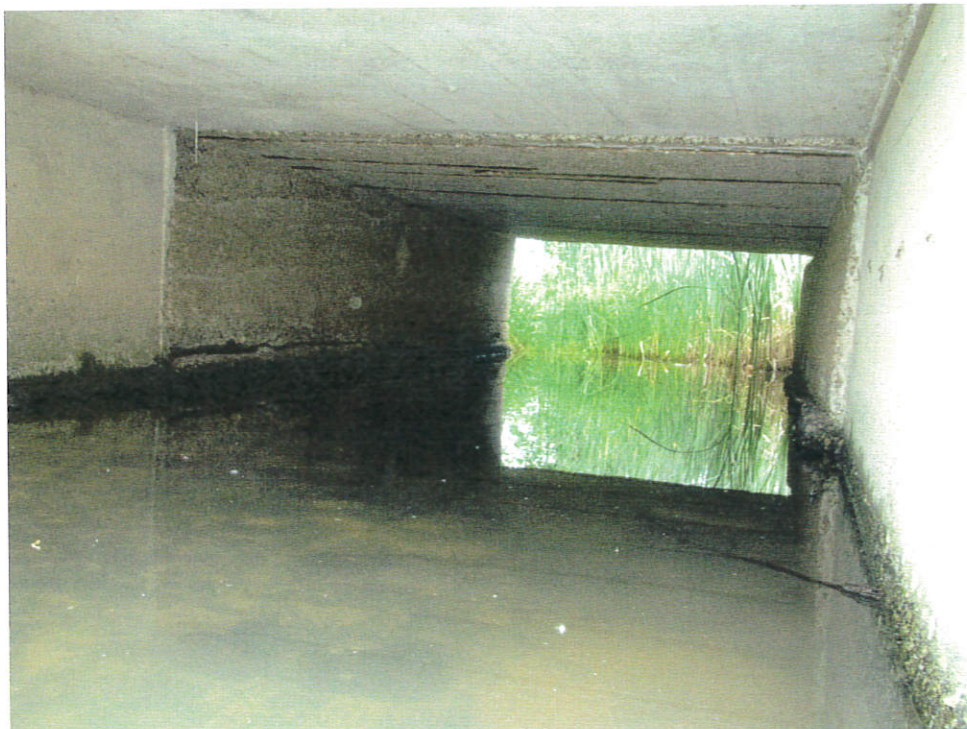
Viewing the interior of the structure from the west end

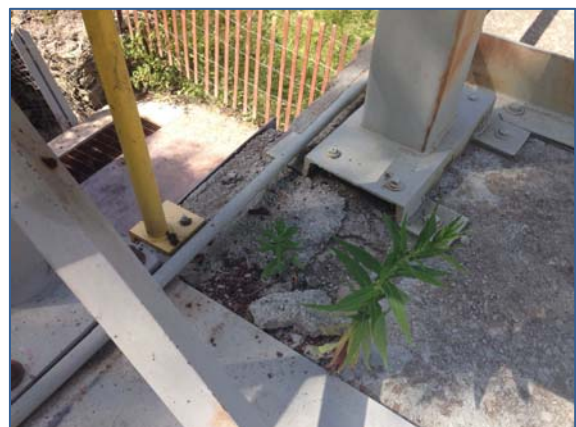
**Figure 3: Localized Concrete Spall**

The west cell has been infilled with dam equipment. The centre and east cells contain coated steel sliding gates. In general, the dam structure is in good condition, with limited, localized areas that contain minor cracks and concrete spalls (ref. Figure 3.) Localized repairs should be completed to the cracked and spalled concrete at the same time when other work is being completed on the dam structure.

2. Dam Structure Rehabilitation: Localized repairs to the existing concrete on the rigid frame structure.

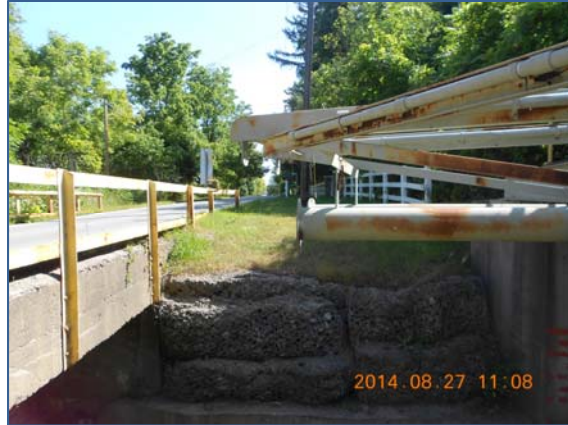
Figure 2: Upstream Embankment

The upstream embankment is retained by the the adjacent retaining structures, consisting of a cast-in-place concrete wall supporting an overlying gabion basket wall (ref. Figure 4.) The gabion basket wall has been grouted on the top and inside face. Both the concrete and gabion walls appear to be stable with no noted movement of the wall or retained soil behind the walls.

The downstream embankment is similar to that noted at the upstream side of the dam structure. No signs of movement or rotation were noted during our field review. Remedial measures to the embankments are not recommended at this time.

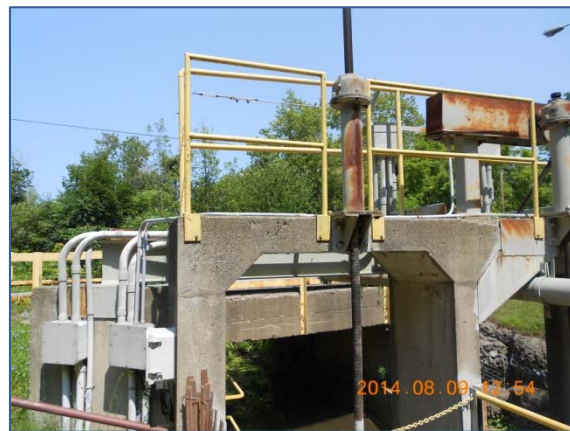
Figure 3: Railings

The railings located on the dam structure are substandard and do not meet current code requirements. Further, in general terms railings are noted to be in fair condition (ref. Figure 5.) It is recommended that the railings be replaced with a new, hot-dip galvanized steel railing system. Additionally, fencing around the downstream side of the dam structure should be replaced with a more permanent fencing system when future work is completed.

1. Railing Enhancements: It is recommended that the existing railing system be replaced with a new, hot-dip galvanized steel railing system that is compliant with current code requirements.

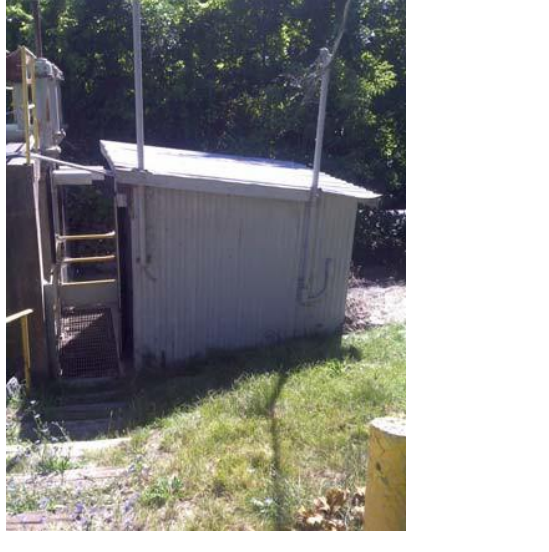
<p>The pump house corrugated steel structure is in very poor condition with notable damage and holes in the roof, which allows rainwater to enter during rainstorms. We suggest that this pump house be replaced.</p>

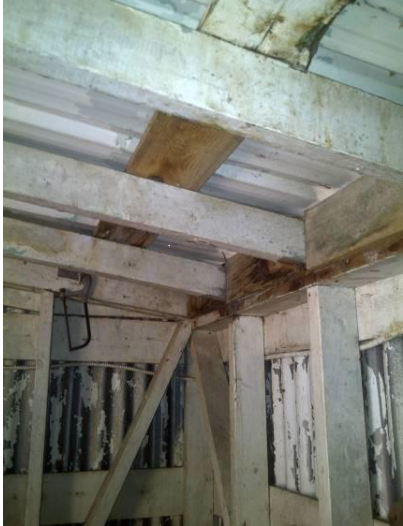
<p>The internal construction of the pump house is in very poor condition. The wooden beams supporting the walls and roofing show significant weather damage and rotting. The corrugated steel walls, floor leak and the room is not properly insulated. This is a very poor environment to house electrical equipment.</p>

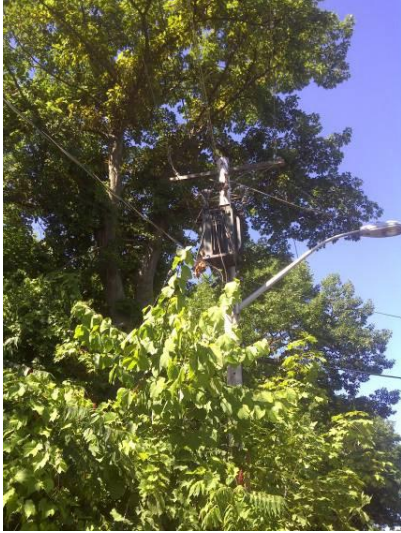
<p>The transformer appears to be quite old and should be replaced. The overhead station feeder lines are susceptible to weather damage and are showing signs of aging. We suggest replacing the transformer and feeder cables.</p>

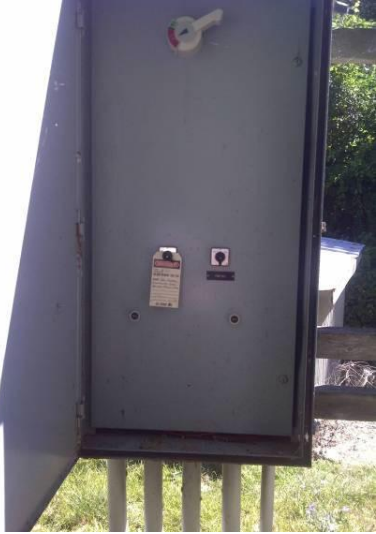
<p>The river pump starter panel has been modified several times over the years and now only provides power and manual control for River Pump 2. The starter panel appears to be in reasonably good condition, but needs minor repairs and clean up.</p>
4. River Pump Power and Starter Panel Structure

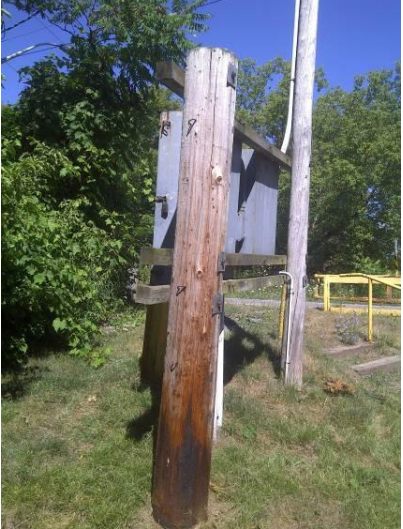
<p>The telegraph-pole structure is beginning to show signs of weather damage and aging, and will need a replacement if the river pump remains in service.</p>

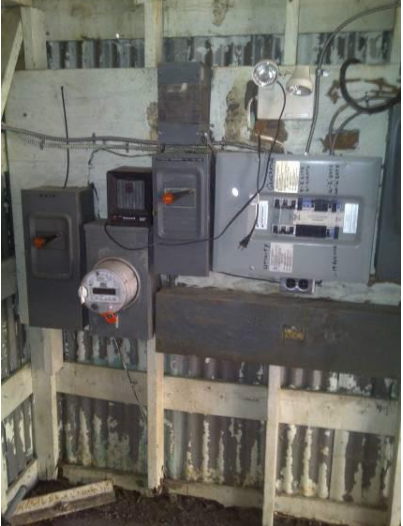
<p>The majority of this equipment is in fair condition, with the exception of the well pump starter and can continue to be used for approximately the next 3 years. However, due to the pump stations structural issues and lack of insulation we recommend replacement.</p>

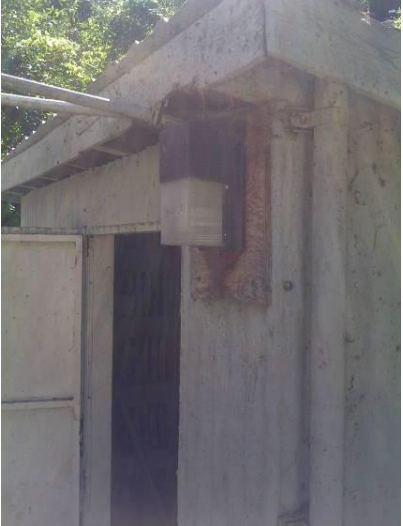
<p>The outdoor light is generally in poor condition, has limited area lighting capacity and is beyond its asset life. We recommend replacing the existing light and adding additional lighting to the dam structure, to ensure that code and health and safety regulations are met.</p>

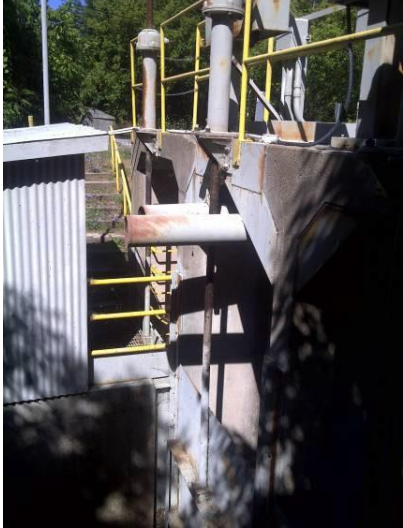
<p>All of the Dam gate mechanisms appear to be in reasonably good condition. The actuators may require minor repair and maintenance to bring them to fully operational condition. The gates and slide have been modified over the last few years and nylon slides have been installed, which will allow the gates to operate more efficiently. We suggest that minor repair and general maintenance be carried out.</p>

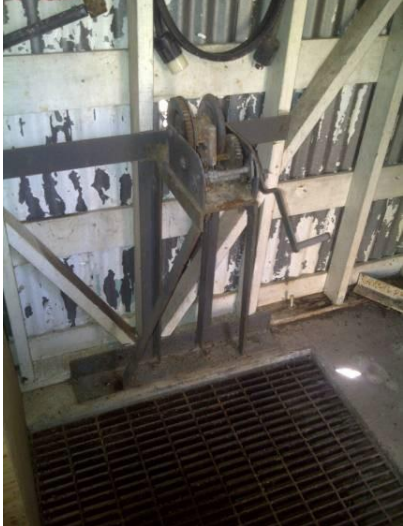
<p>The Hoist appears to be in reasonably good condition.</p>

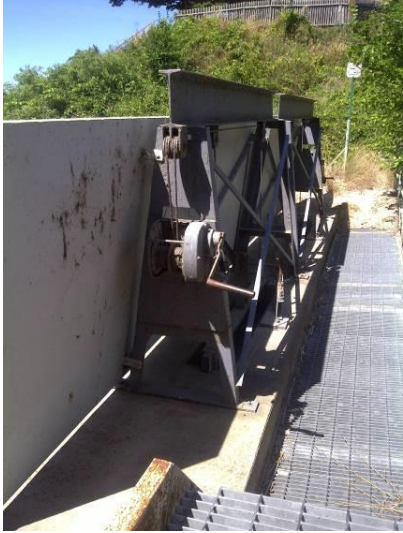
<p>The gates and hoist mechanism are in reasonably good condition.</p> <p>You will not that the protective wind/spray shield mounted to the hoist mechanism were added recently (circa 2009-2010).</p>

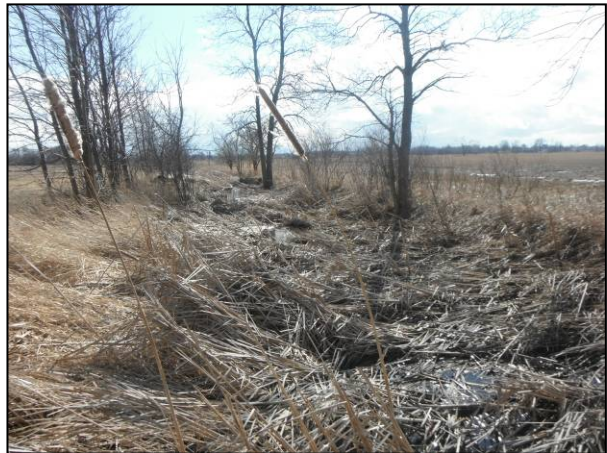
Photo 4: Reach 3-WM showing cattails in drain

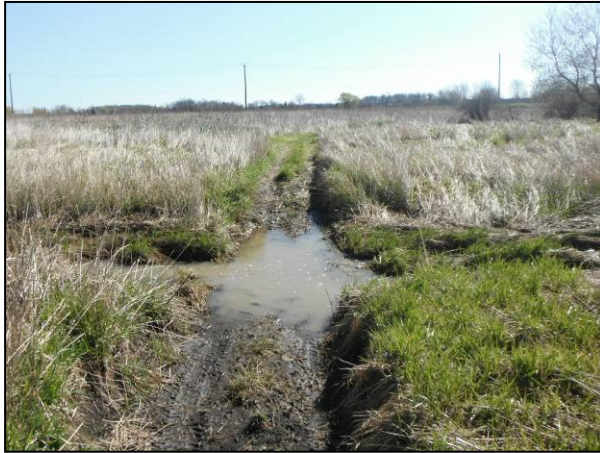
Photo 7: Reach 5-WM, ATV use through drain

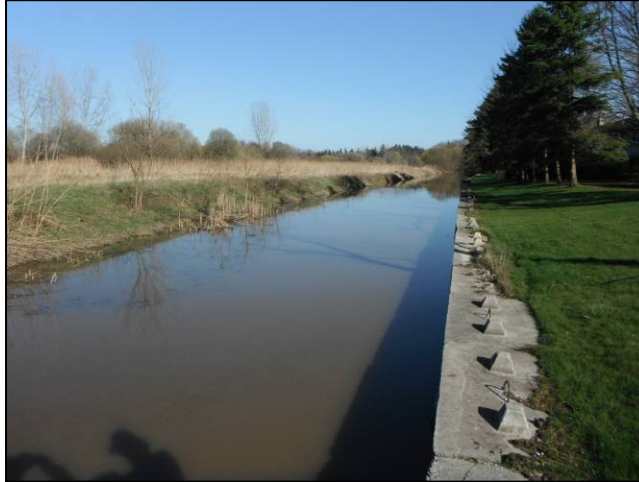
Photo 11: Reach 8-WM, channel character and hardened edge (emergency erosion protection works constructed circa 2008)

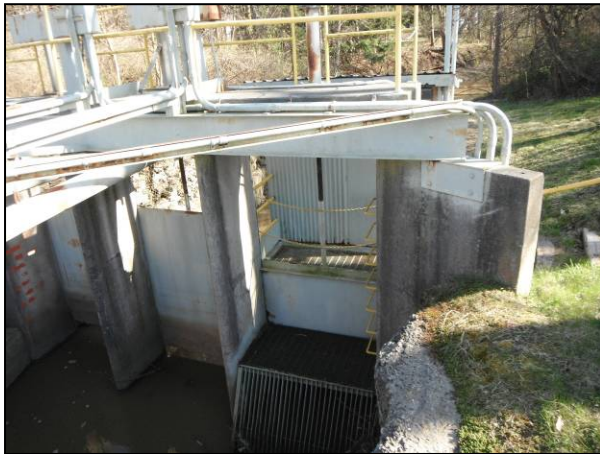
Photo 12: Reach 9-WM, water control structure at Lakeside Road

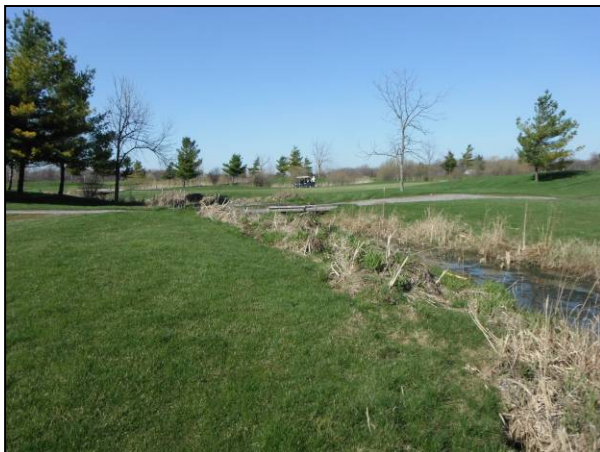
Reach 11-WM runs north-south through the Whiskey Run Golf Club. The drain has been altered to have a sinuous shape and is mowed to its edges with occasional small shrubs and cattails within the channel. This shape is the result of the drain being altered/constructed by the property owner without the prescribed requirements of the Drainage Act R.S.O. These works were incorporated afterwards under a Report by Wiebe Engineering Group Inc. dated November 15, 1996. Numerous small bridges cross the drain to facilitate golf cart traffic through the course.

Photo 16: Reach 11-WM, drain character, showing cattails in channel

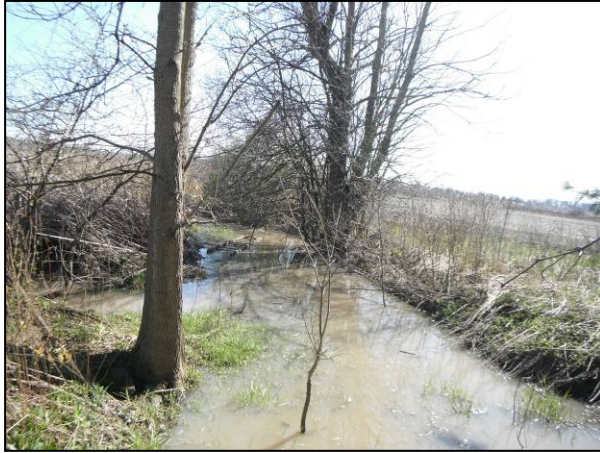
Reach 12-WM runs north-south from the northern extent of the Whiskey Run Golf Club through agricultural land to the southern extent of a deciduous swamp which lies south of the Friendship Trail and west of Lorraine Road. The drain has a dense 2-4m wide buffer of deciduous shrubs on both sides, followed by agricultural fields. Reaches 12 through 14 depict a lack of routine drain maintenance.

Photo 18: Reach 12-WM, drain character

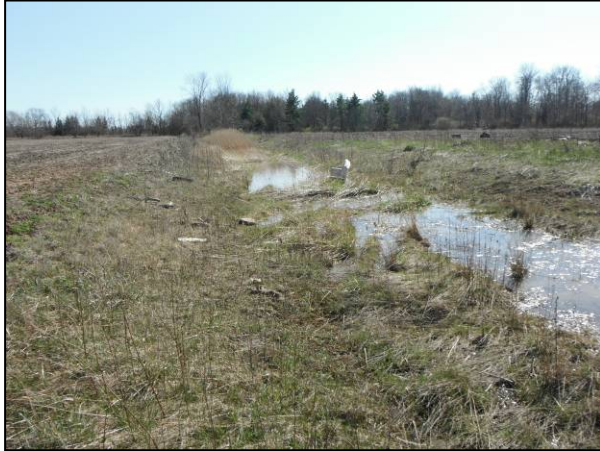
The naturalized character of Reaches 12 through 14 are likely due to a lack of routine drain maintenance.

Photo 22: Reach 14-WM, channel character

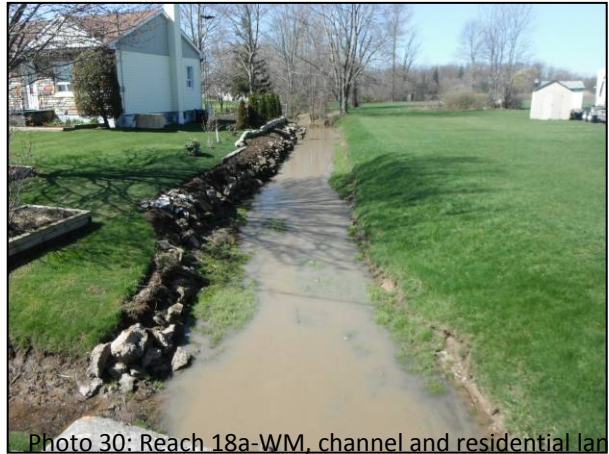
Reach 18a-WM runs northeast from Killaly Street East to Weaver Road. The channel runs along the back of residential properties which front on both Killaly Street East and Weaver Road. The property owner in photo 30 has since altered the slope of the north bank of the drain.

Photo 30: Reach 18a-WM, channel and residential land

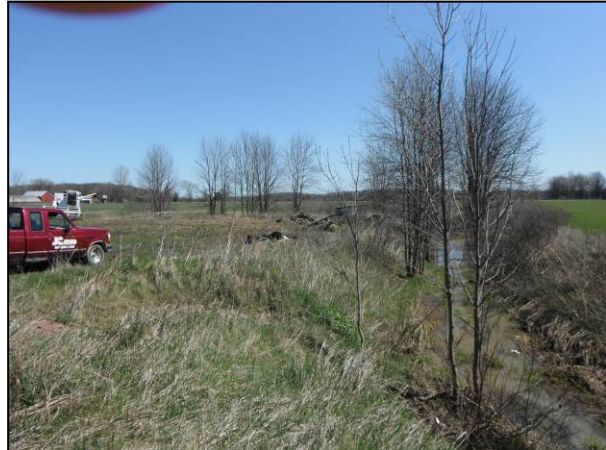
Reach 19-WM runs generally north-south from Highway 3, adjacent to a car-racing track, then through meadow marsh to a 90-degree bend to the east. The adjacent lands vary from agricultural to cultural meadow to thicket swamp. The car-racing track property extends to the channel and many abandoned vehicles, parts, and other debris are scattered on this property.

Photo 34: Reach 19-WM, channel and derelict vehicles

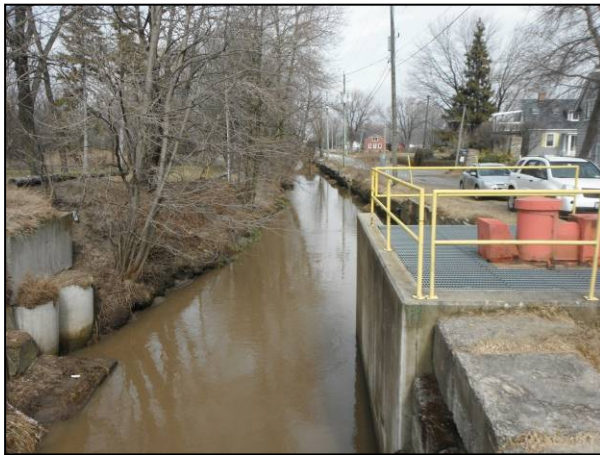
Photo 37: Reach 1-B, water control structure

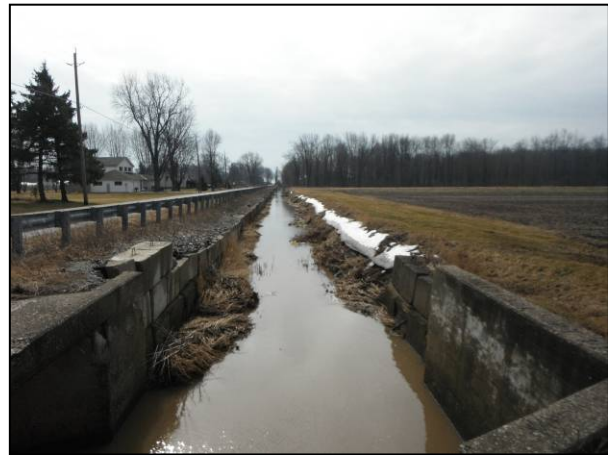
Photo 38: Reach 1-B, hardened banks and adjacent agricultural land

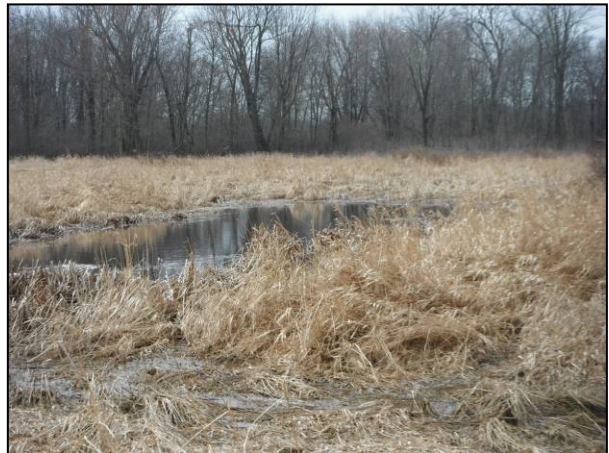
Reach 4-B runs east-west through an agricultural field. The field to the north is actively cultivated to the top of bank, while the field to the south is fallow, with dense herbaceous vegetation and one tree. Patches of standing water were observed in the field to the south, possibly indicating a lack of routine drain maintenance, during the field investigation.

Photo 44: Reach 4-B, flooded field south of channel

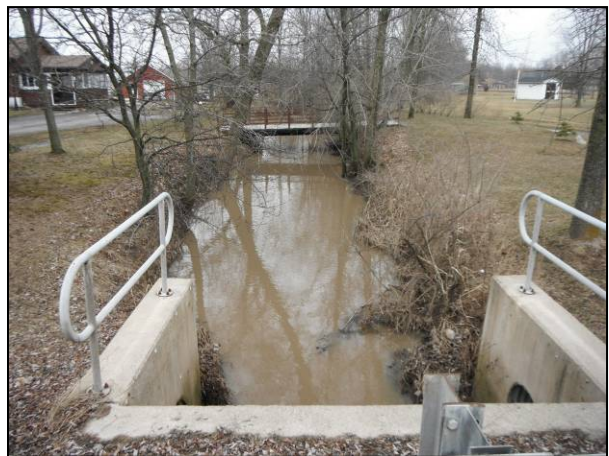
Photo 48: Reach 6a-B, Hwy # 3 culvert crossing headwall & lateral drainage (piped roadside ditching)pipinginterface. Former Geo. A. Schooley Award Drain. 16

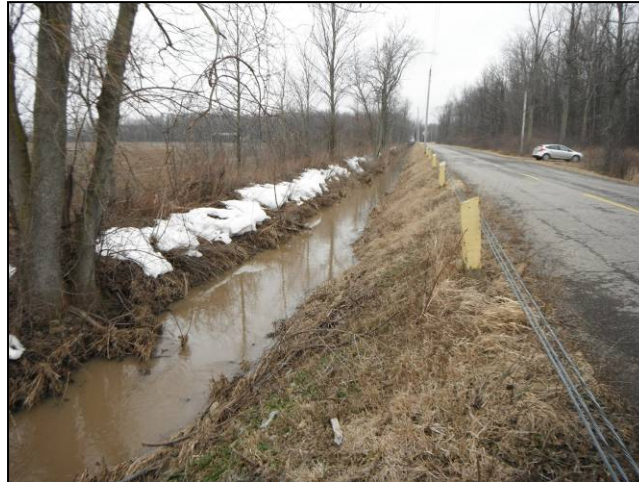
Reach 6b-B runs north-south adjacent to White Road on the road’s west side. The profile of the drain follows the existing elevation/contour of the bedrock along this reach; the design grade has never been achieved here since 1916. The adjacent land use on the drain’s west side through the southern half of this reach is agricultural, while the northern half is deciduous swamp. Three driveway bridges, circular steel/corrugated steel pipe structures, span the drain through this reach.

Photo 49: Reach 6b-B, channel character adjacent to White Rd.

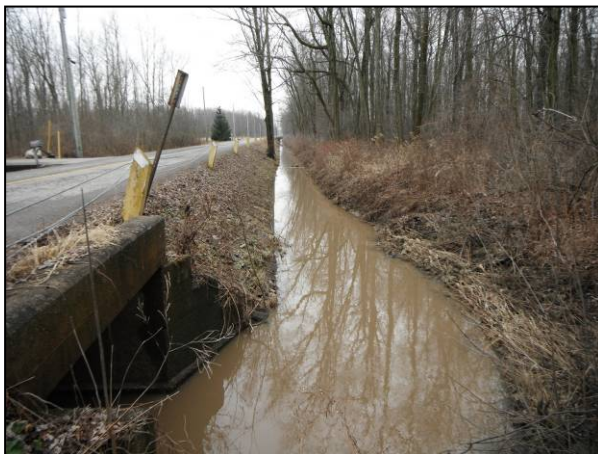
Reach 8-B runs north-south adjacent to White Road on the road’s east side, then takes a 90-degree bend to run east-west between an agricultural property and a deciduous swamp. Since D&A’s field work was undertaken the Municipality has carried out shoulder stabilization works through the installation of Gabion wire baskets on alternating sides of the bridge approaches and safety improvements through the installation of guide rails. The entire east side of the drain through this reach is treed while the west side is adjacent to White Road, with no buffer, or is adjacent to agricultural pasture with has a 3-4m herbaceous buffer.

Photo 50: Reach 8-B, channel adjacent to White

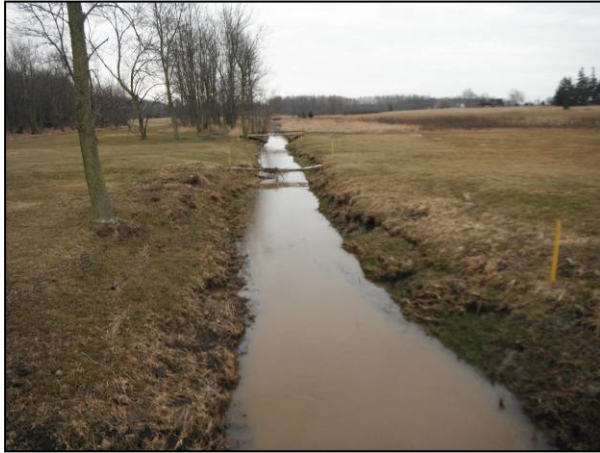
Reach 9-B runs generally north-south through agriculture and the Emerald Pines Golf Club to Concession 2. The adjacent land uses are meadow marsh, agriculture, and the golf course. The amount of buffer is good except in the golf course, where the vegetation is mowed to within 1m of the top of bank. There is one concrete bridge structure crossing and several clear span wooden bridges throughout the golf course, including associated irrigation/utility pipe crossings in this reach. North of Concession 2 the East Branch of the Beaver Dam Drain (Reach 11-B) breaks off to the east while the Reach 10-B continues to the north.

Photo 52: Reach 9-B, channel through golf course with crossings

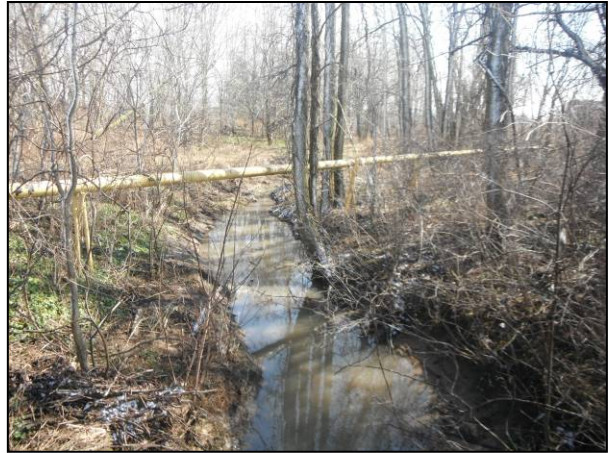
Photo 61: Reach 13-B, pipe crossing the drain and adjacent forest

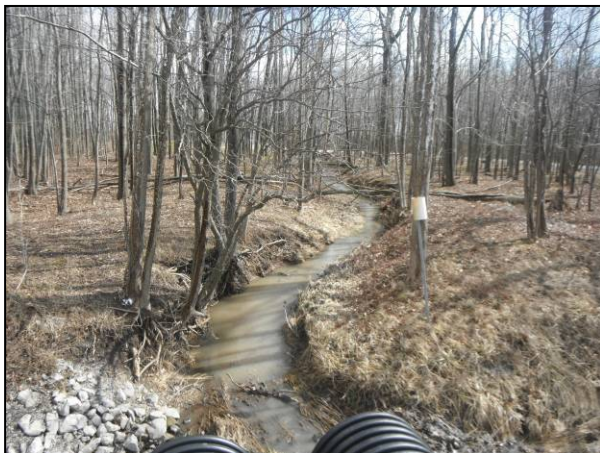
Photo 62: Reach 14-B, channel character, Miller Road cross culvert at point of discharge of roadside ditching system into the West Branch of Beaver Dam Drain.
